Manhole Inspection Summary

Manhole # S45GG_052MH

Insp Date: **8/14/08 11:34 AM**

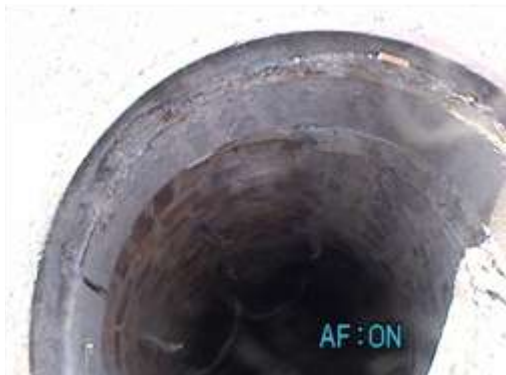
Defect 2

☒ **Leaks**

Frame leaks

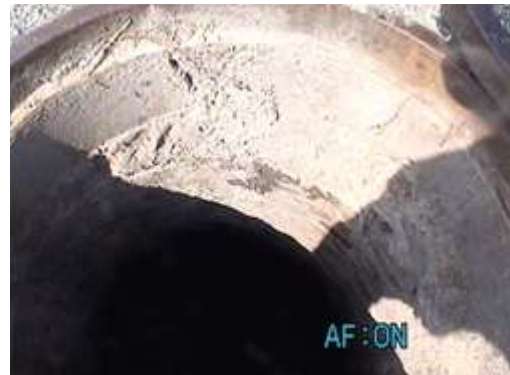
Defect 1

Infiltration: ☐ None ☒ **Joint** ☐ Cracks ☐ Mortar ☐ Roots ☐ Wall

Infiltration: ☐ None ☐ Joint ☐ Cracks ☐ Mortar ☐ Roots ☒ **Wall**

Infiltration

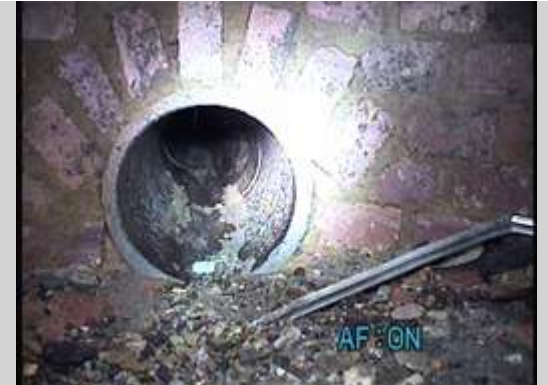
12 O'Clock Outflow

8 in. Circular Gravity Sewer
Pipe Out @ 12 O'Clock

Deposits: ☐ None ☐ Mud ☐ Sludge ☒ **Debris** ☐ Grease

Silt Depth: **0.15** (in.) Deposits Extent: **Light**
